Kiribati chemical and waste management advice and Banaba reconnaissance mission

Written by:
Melanie Ashton and Mike McRae Williams

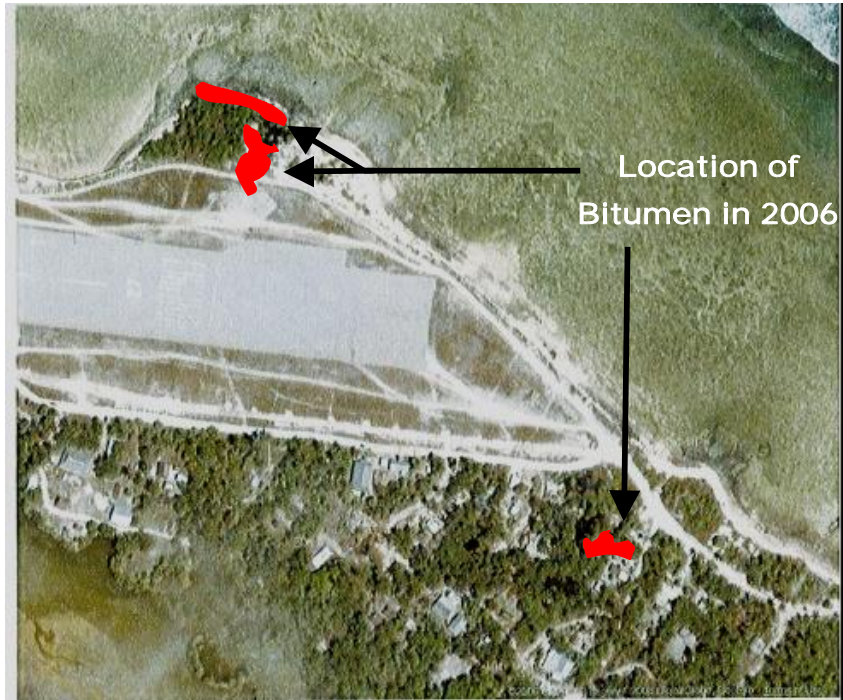
Plate 1: Location of Bitumen 2006 - Tarawa Airstrip

The northern bitumen area condition was similar to that observed in 2006. Bitumen is still moving onto the shore platform and into dry depressions in the sand dunes along the low sea cliff. This also is clearly contaminating the seawater of the intertidal zone and the bitumen on the dunes is likely to be contaminating the ground water whenever it rains.

To alleviate the clear environmental damage that has occurred since the construction of the runway and the recent deposition of the material on the shore platform and in the water filled depression, the bitumen source must be removed from the area and contained. It is not acceptable to leave it in its present condition, doing so will lead to continual contamination of the shore platform, surrounding soil and the water table. The source must be removed.

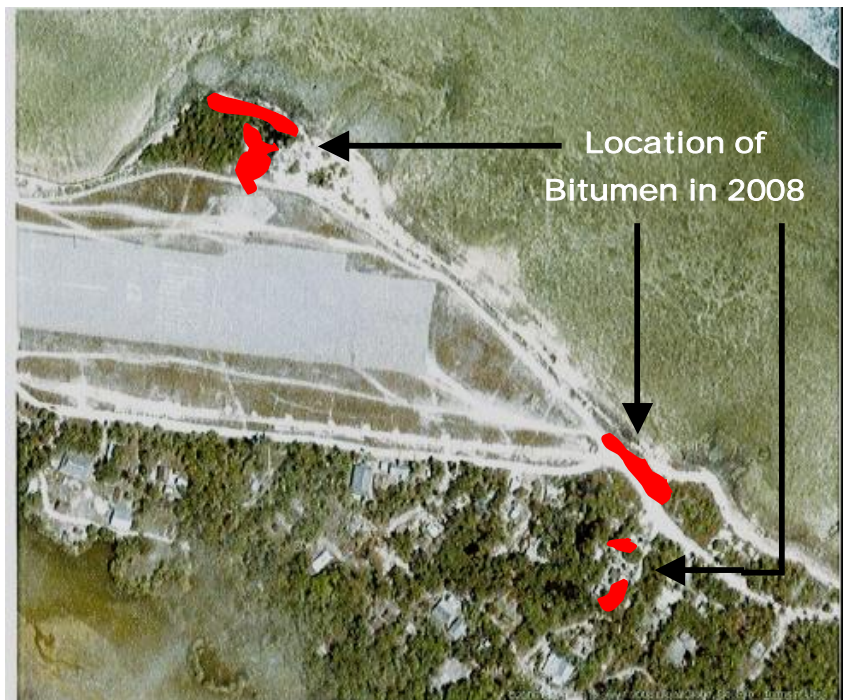
Plate 2: Location of Bitumen 2008 - Tarawa Airstrip

During the Team's 18 July visit, it was observed that the southern bitumen area near the houses had been partially removed by machinery and deposited over the low sea cliff onto the shore platform. Much of the bitumen remained partially liquefied and was slowly covering the shore platform and entering the sea. Bitumen had also been pushed into a water-filled depression, which appeared to contain groundwater, as it was at the same level as the house
