BEACH ECOSYSTEM-BASED ADAPTATION

Abaiang, Kiribati

Beach ecosystem-based adaptation: Abaiang, Kiribati.
Apia, Samoa : SPREP, 2016.

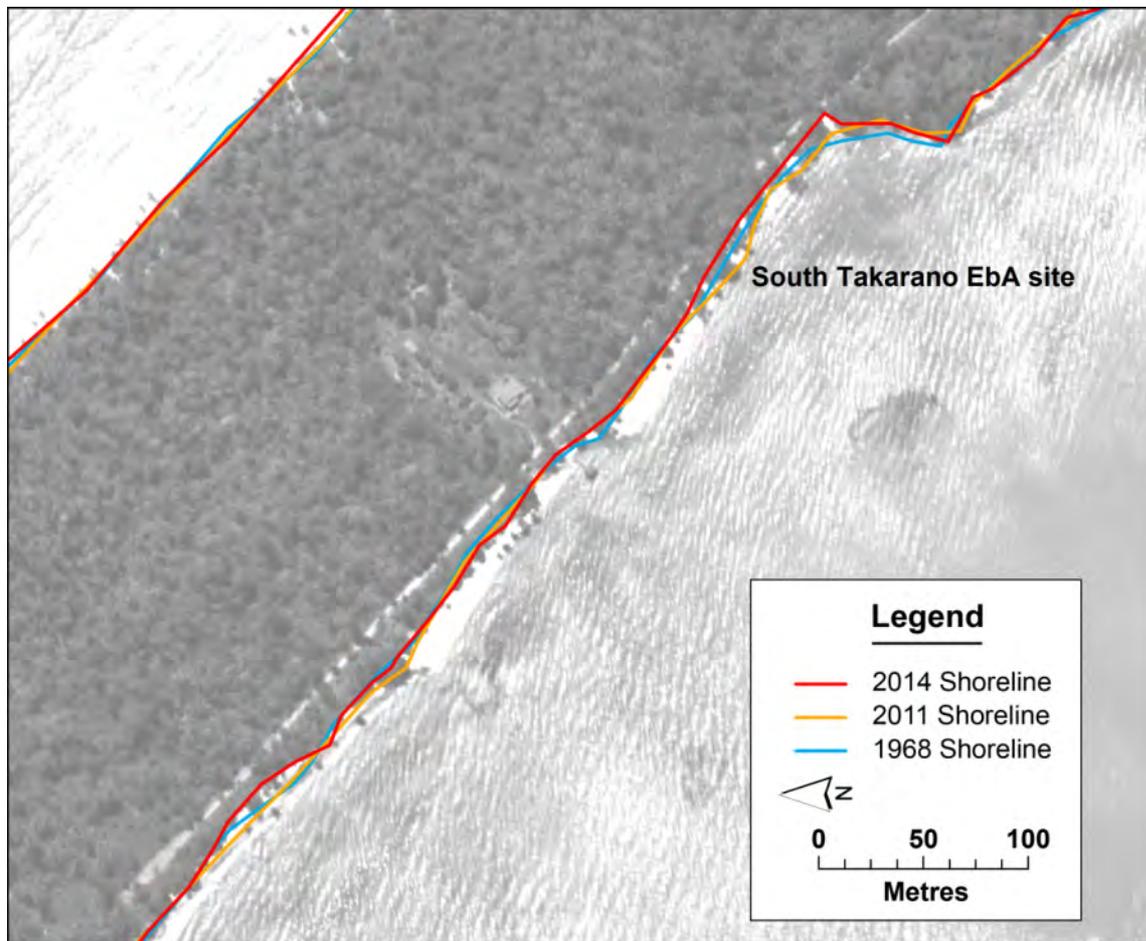
Figure 2. GIS analysis of coastal change at south Takarano.

January 2015. GIS results showed coastal retreat of most of the northern lagoon shoreline, with significant loss in the last 3 years (Figure 2). South of Takarano (Table 1, Figure 2) the beach had eroded to undercut the main road, with a 50 cm scarp above a concave beach profile (Figure 3). A brush structure was built of 5.9 m in length and up to 1.85 m in width, by 6 volunteers from Takarano village.

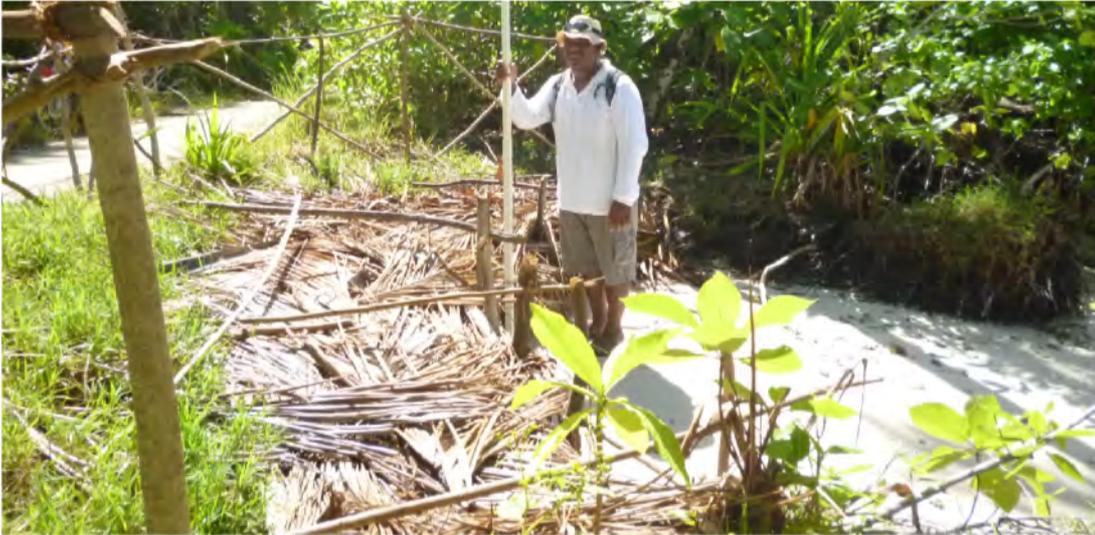
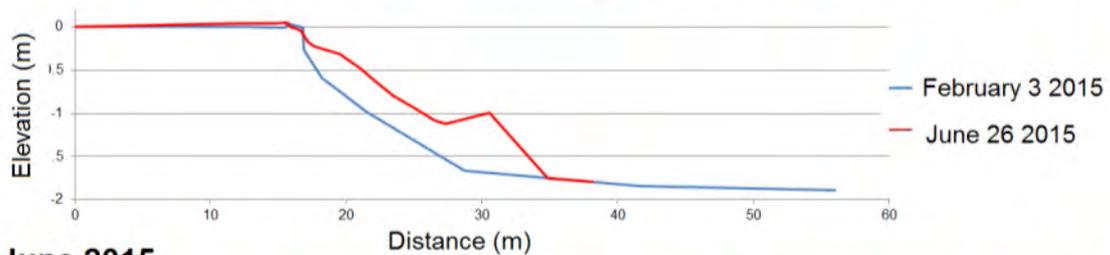
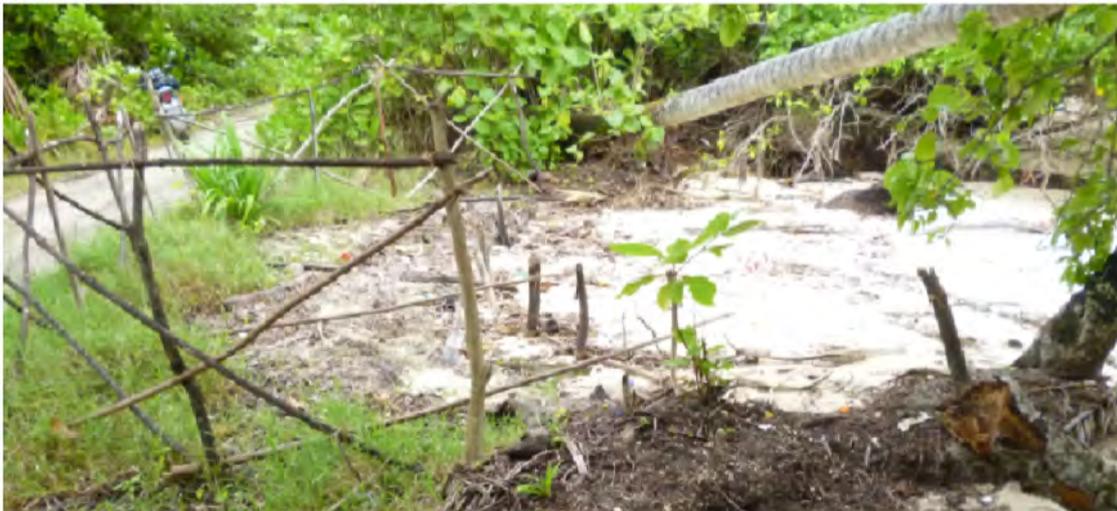
Figure 3. Profile diagram of EbA works south of Takarano.

In June 2015 the beach had accreted to cover the brush structure, and the profile of the beach had become convex, and using the guidelines in Ellison et al. (2015) the beach had recovered to a level 3/2. The beach sand offshore of the brush structure had accreted about 50 cm (Figure 3). Other erosion sites on this section of road identified in MISA (2008) all showed the road to remain to be undercut, with no beach infill. This site could recover further if revegetated, with beach vines, grasses and tree seedlings, to give it resilience against storm swell events.

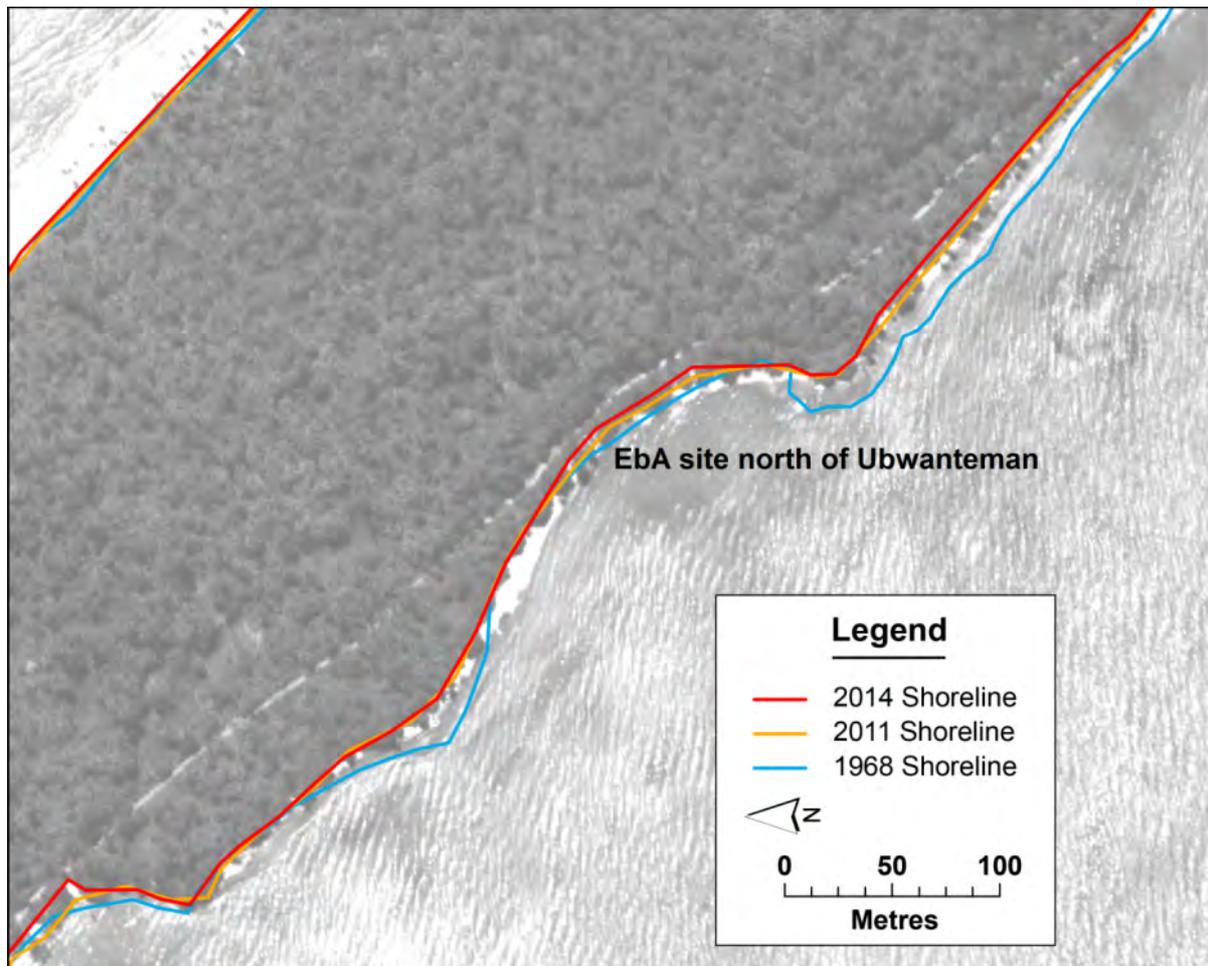
Figure 4. GIS analysis of coastal change at north Ubwanteman.

North of Ubwanteman (Table 1, Figure 1) the beach had eroded to undercut the main road, with a 0.5 m scarp above a concave beach profile (Table 3). GIS analysis showed significant retreat along this whole section of lagoon shoreline (Figure 4).

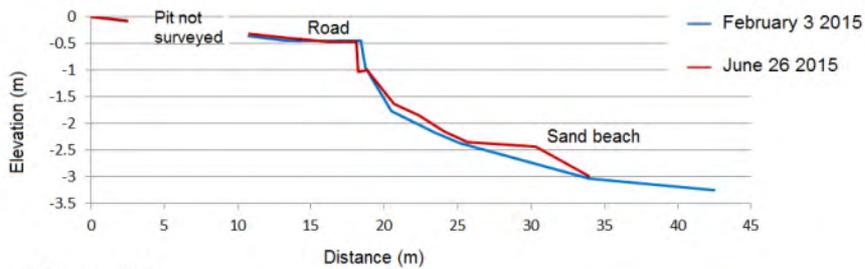
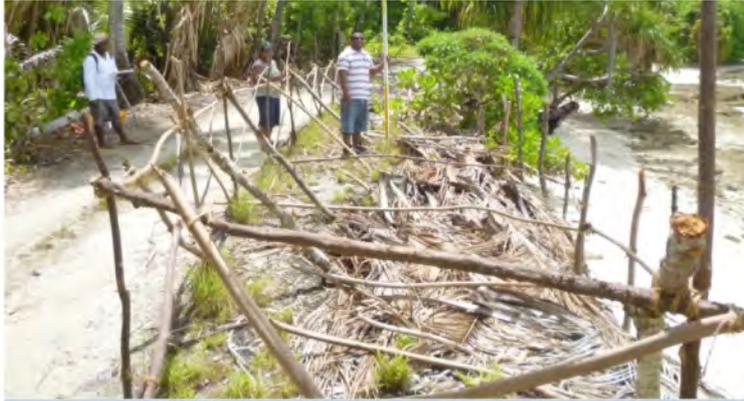
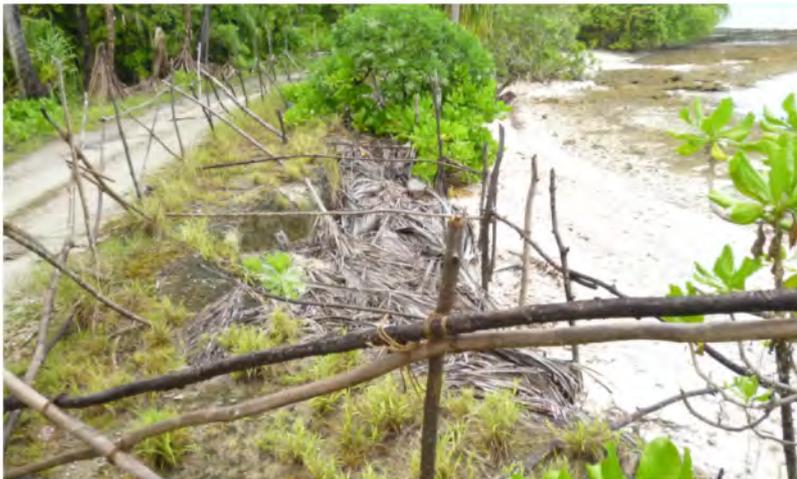
Figure 5. Profile diagram of EbA works north of Ubwanteman.

A brush structure was built of 23.4 m in length, and up to 2.9 m in width, with a small *Messerschmidia* tree in the centre (Figure 5). In February 2015, the high tide mark was inside the brush structure, indicating the high tide waters were washing at the sand in the scarp below the road edge.

In June 2015, the brush had compacted and sunk, and needed maintenance and infill, which police have volunteered to undertake. Resurvey of the beach showed that while the road base has eroded a little, the majority of the beach has accreted by at least 0.2 m (Figure 5). The upper beach remains concave in profile, while the lower beach has developed a convex bar. This site could be further stabilised with maintenance and repair of the brush structure, along with the planting of beach vines around the top of the beach.

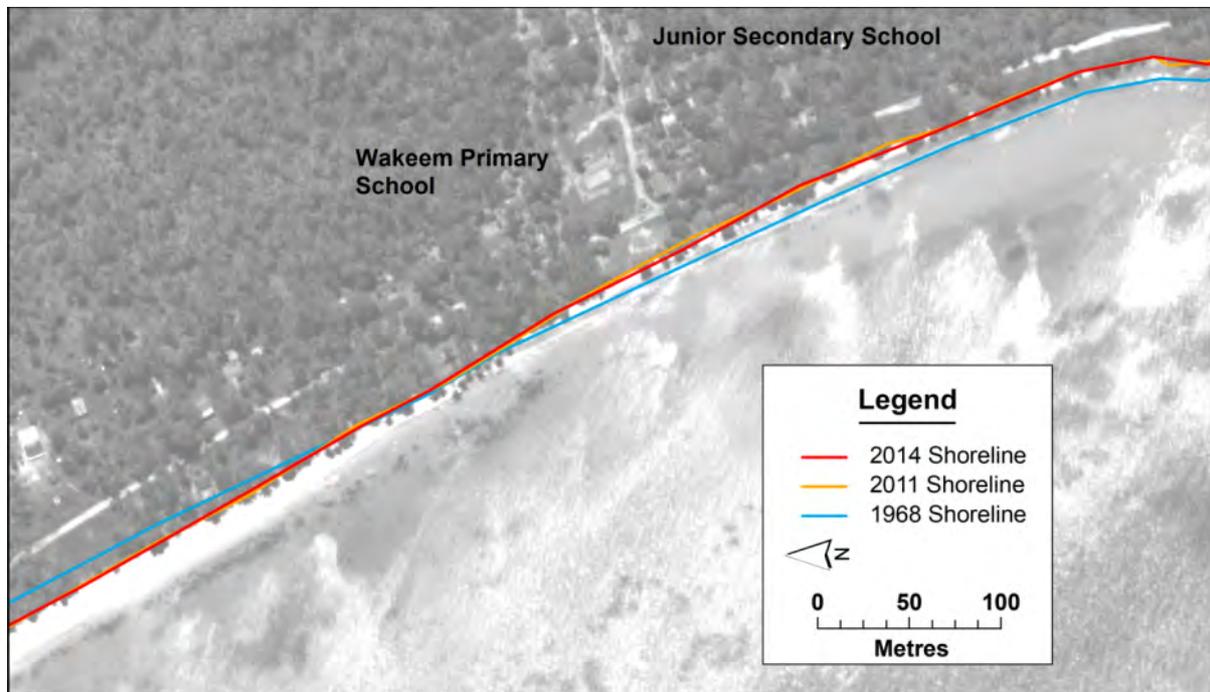
Figure 6. GIS analysis of coastal change at Wakeem Primary School.

(level 4), with disturbed vegetation and a sand cliff at the top of the beach of up to 80 cm. Teachers said that the school was established in 1999, and soon after lost a number of classrooms and a maneaba on the seaward side of the road, with loss of about 30 m of land bit by bit. GIS analysis showed this coastal retreat (Figure 6).

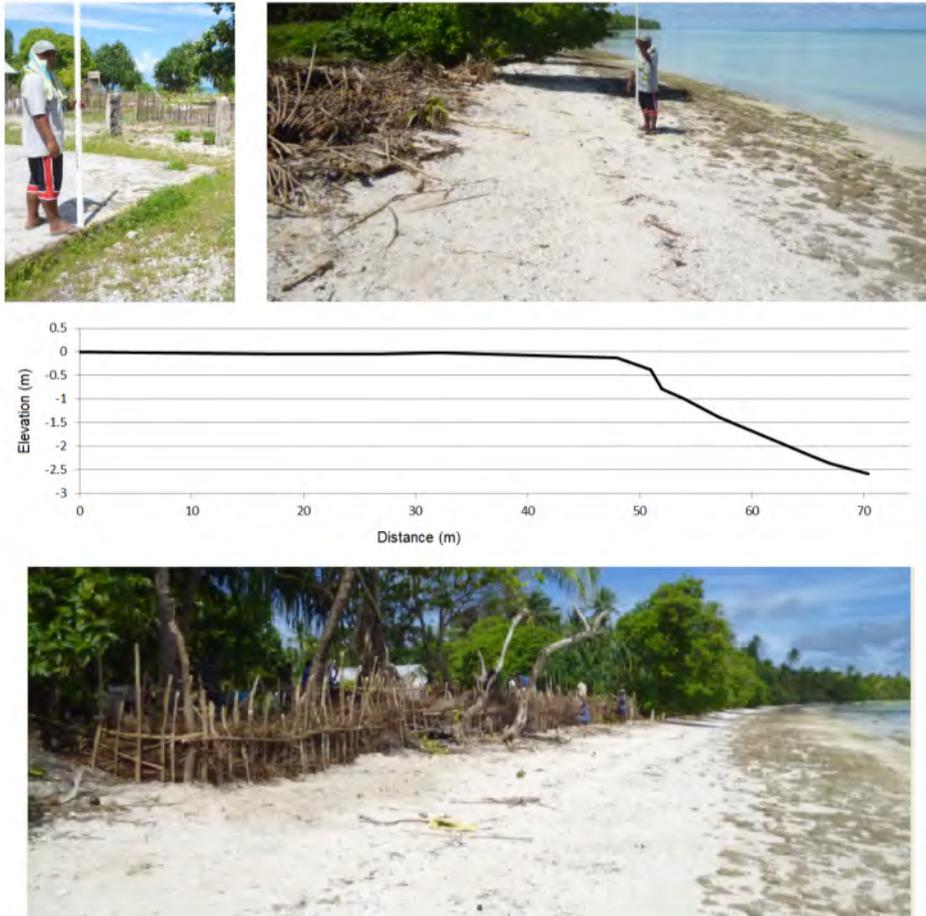
Figure 7. Beach profile diagram and EbA works at Wakeem Primary School.

Pigs were tied to coconut trees at the northern edge of the beach, and had been digging and uprooting vegetation so no ground vegetation remained, loosening sand for erosion at high tide. The surveyed profile (Table 4, Figure 7) showed a 0.4 m scarp at the top of the beach, below which the beach profile was flat or straight in shape.

A large brush structure was built of 36 m in length, with the northern half built by 20 volunteers from Aonbouaka village, and southern half by Koinawa village (Figure 7, base). The width was up to 2.8 m, and infilled by dense coconut fronds and woody brush. Two access pathways were created within the brush structure, and *Pandanus* seedlings and cuttings planted behind this by school children.

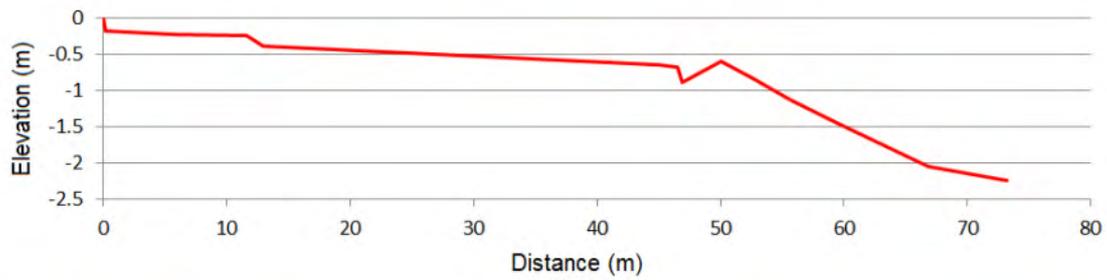
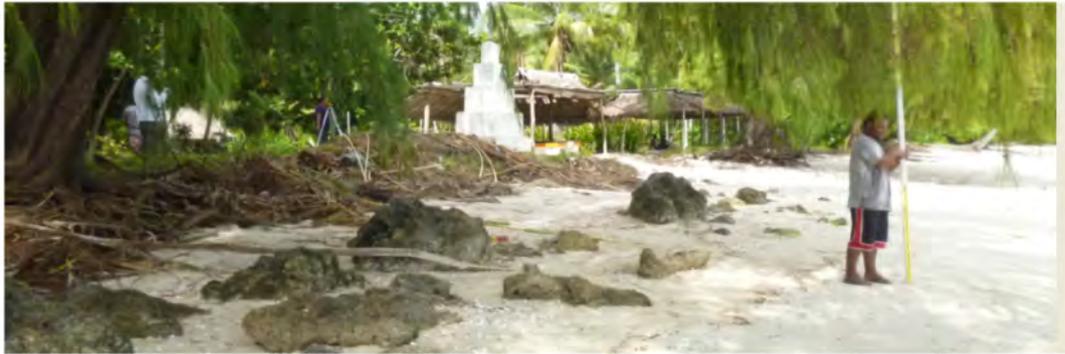
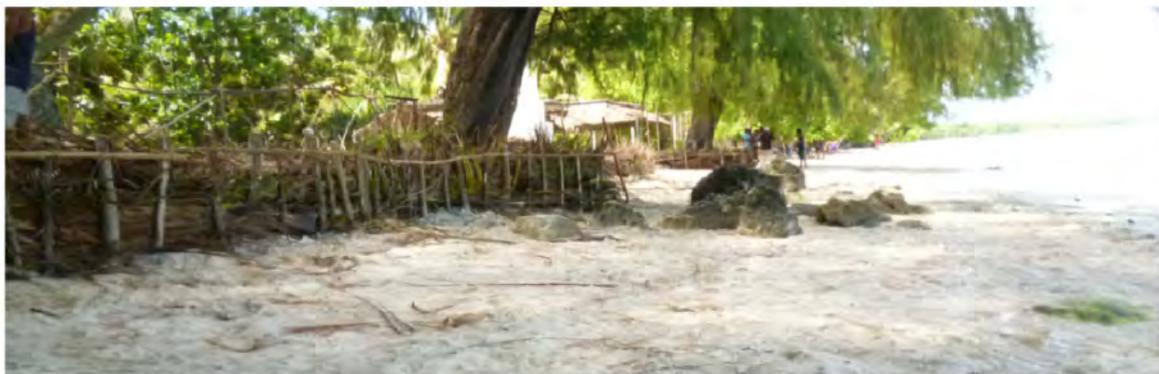
Figure 8. Beach profile diagram and EbA works at St Joseph’s College (north).

To the north of the access road from the junction, where a stone crucifix stands above the beach, a brush structure of 90 m in length was built (Figure 8), of 1.3-2.2 m in width increasing up to 3.9 m where brush surrounded the seaward roots of large trees. Heights of the structure matched decreasing height of the eroding scarp from up to 0.8 m high at the southern section reducing to 0.5 m at the northern end. An access path was created though this about half way along this 90 m length. The northern half of this 90 m structure was built by 20 volunteers from Ewena village, and the southern half built by 27 volunteers from Taburo village (the closest village to the site).

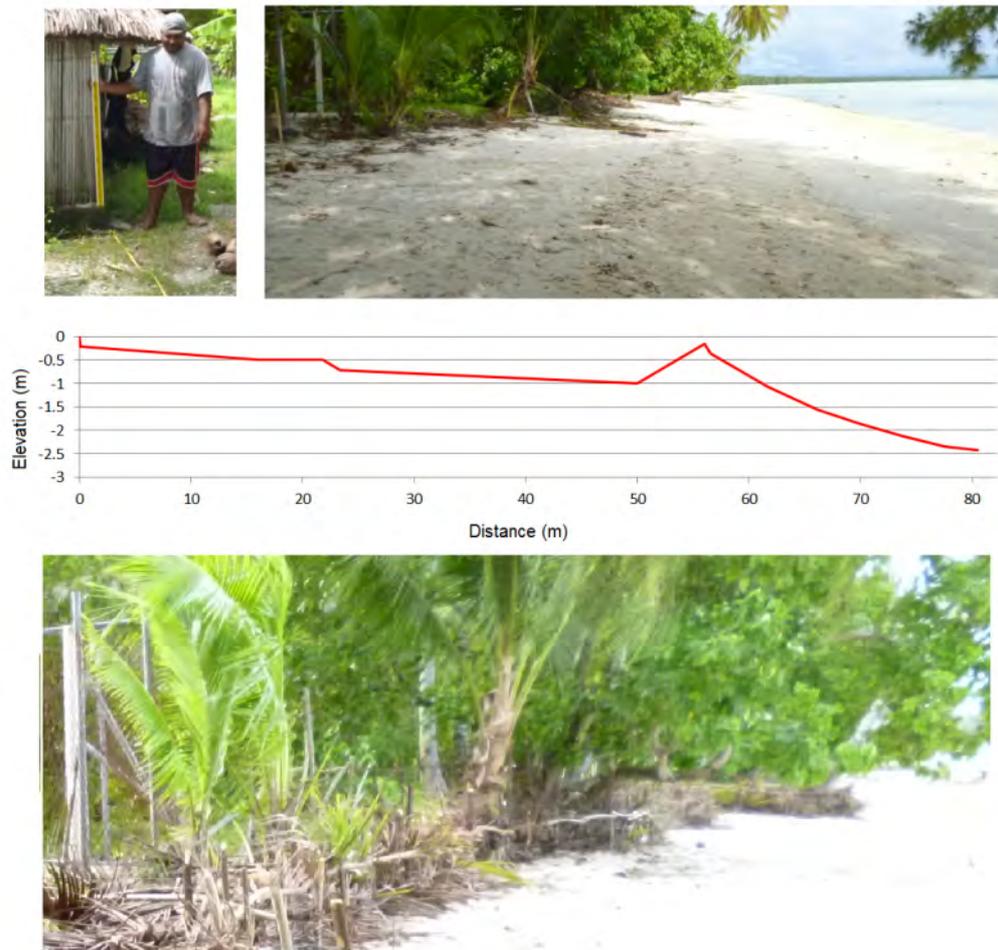
Figure 9. Beach profile diagram and EbA works at St Joseph's College (south).

To the south of the access road from the junction, a brush structure of 50.3 m in length was built by 21 volunteers from Tuarabu village (Figure 9), and included protection to the seaward side of the pre-school playground that had been undercut. Widths were 1.7-3.0 m with the wider sections surrounding the seaward roots of large trees, and heights from 0.5-0.8 m. Staff of St Joseph's College agreed to maintain and monitor the brush structure.

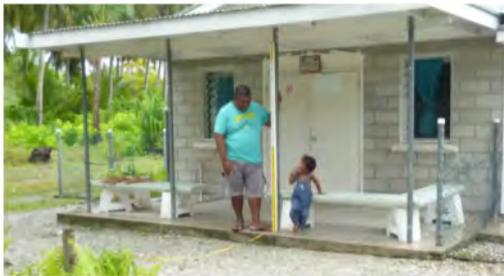
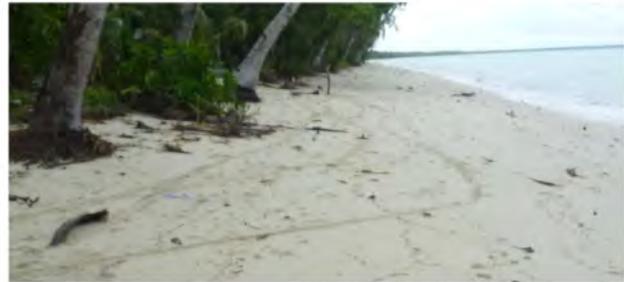
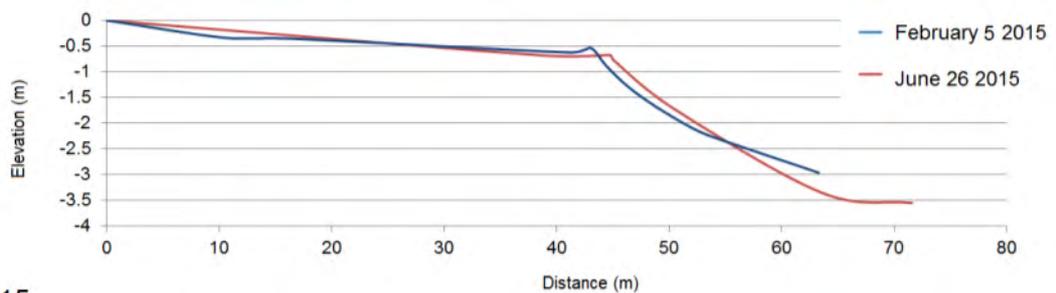
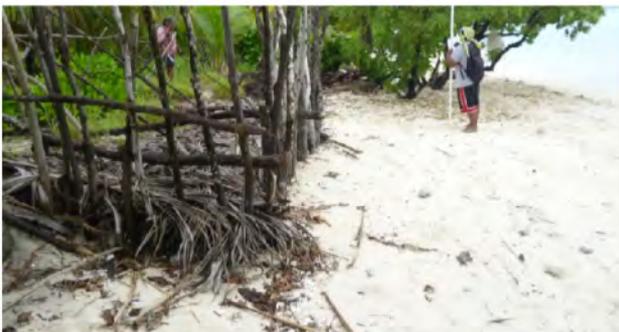
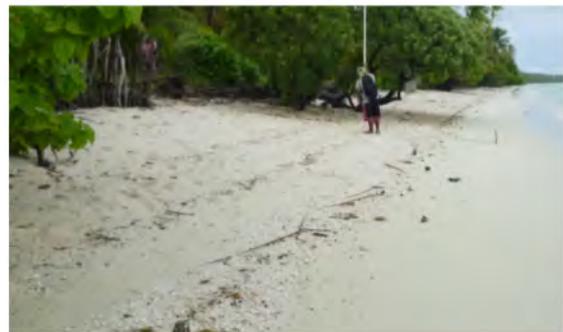
Figure 10. Beach profile diagram and EbA works at Tanimaiaki Clinic.

Opposite a new medical clinic built with European funding, this beach was in a moderately degraded condition, with the high tide mark extending into upper beach vegetation, and some of this had been cut and damaged. GIS results showed <10 m of accretion 1966-2011, and stability with a little erosion 2011-2014. A beach monitoring profile was surveyed, and benchmarked to the floor of the entrance to the medical clinic (Table 7), showing a flat beach profile (Figure 10). A brush barrier was constructed of about 5 m in length, and a further 6 m of access control fencing installed to alleviate pressure on an eroding section with an access path through. This involved the work of 15 volunteers from Tanimaiaki village.

In June, the access fence was no longer there, but the brush structure had largely remained and become infiltrated by sand deposits. This site lacks maintenance as is outside one of the villages. The beach profile results showed accretion of the upper beach by 0.2 m.

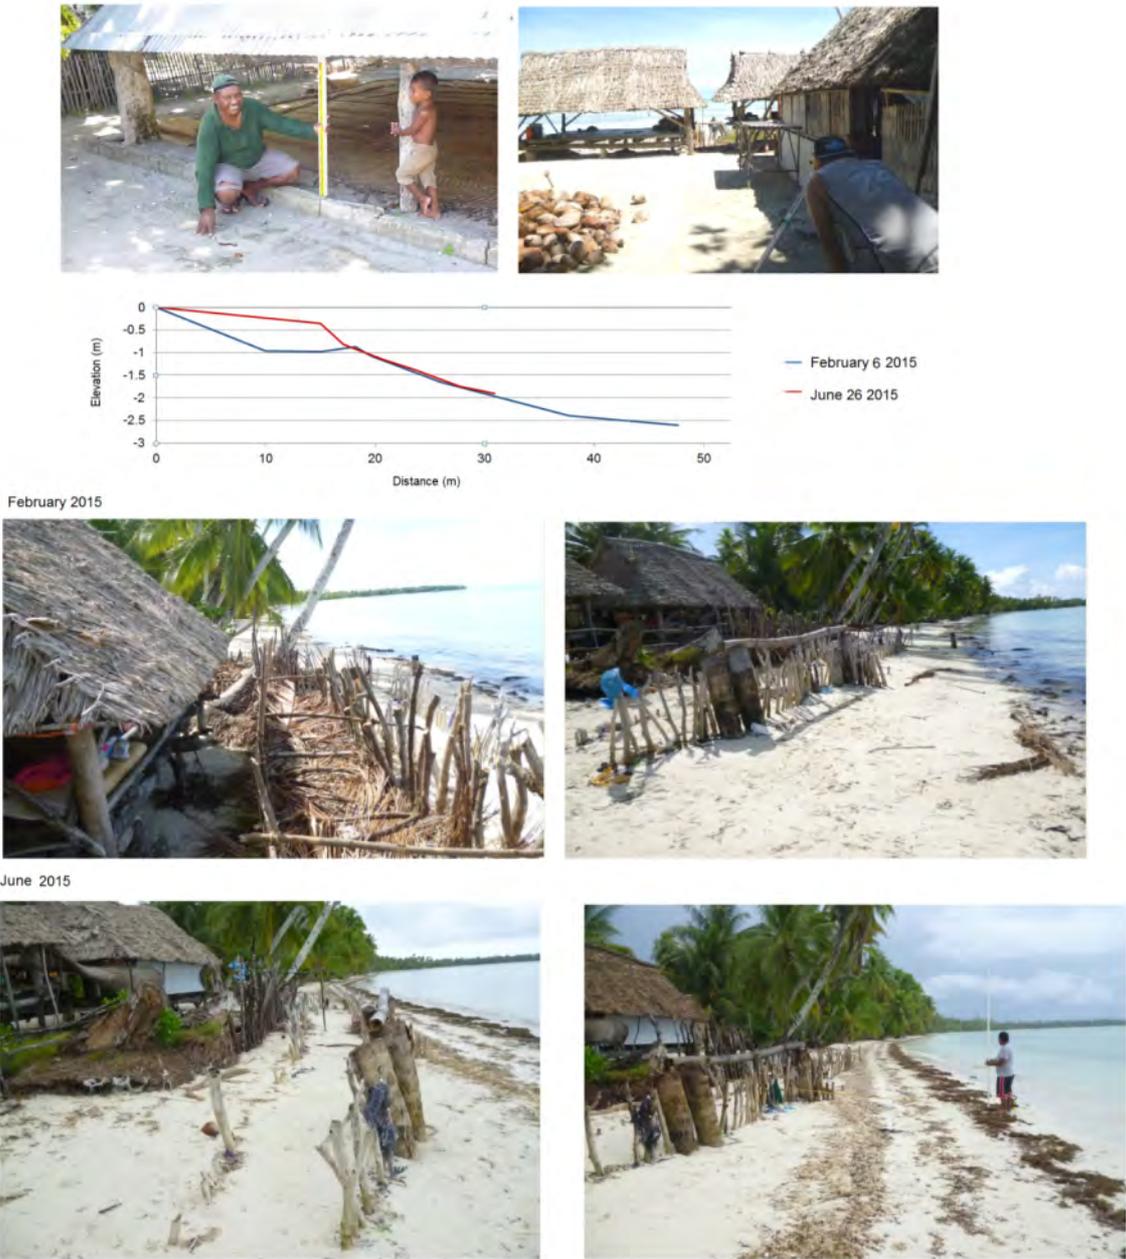
Figure 11. Beach profile transect and EbA works at Taniau.

At the Taniau Kiribati United Church community, the high tide mark extending underneath buildings, and the beach in a degraded condition (level 4-5). At least 40 cm of sand loss was evident from exposed roots of trees. GIS results were inconclusive. Previous coastal protection works had been washed away, and the beach eroded back further.

When revisited in June, residents reported that during two high tides in late February had coincided with high waves from Cyclone Pam. Sand under the village houses had eroded, and waves damaged the brush structure, with cross bracing broken by waves such that the brush washed out. Following this, poles in the brush structure were replaced, these made shorter to reduce drag on waves, matting added, and the structure was extended to the south. The February work proved to be a demonstration, and the design was modified following experience. Sand was also mined from the lower beach and brought up to raise the ground level under village houses, as shown on the left of the profile diagram (Figure 11). The beach part of the profile showed no change.

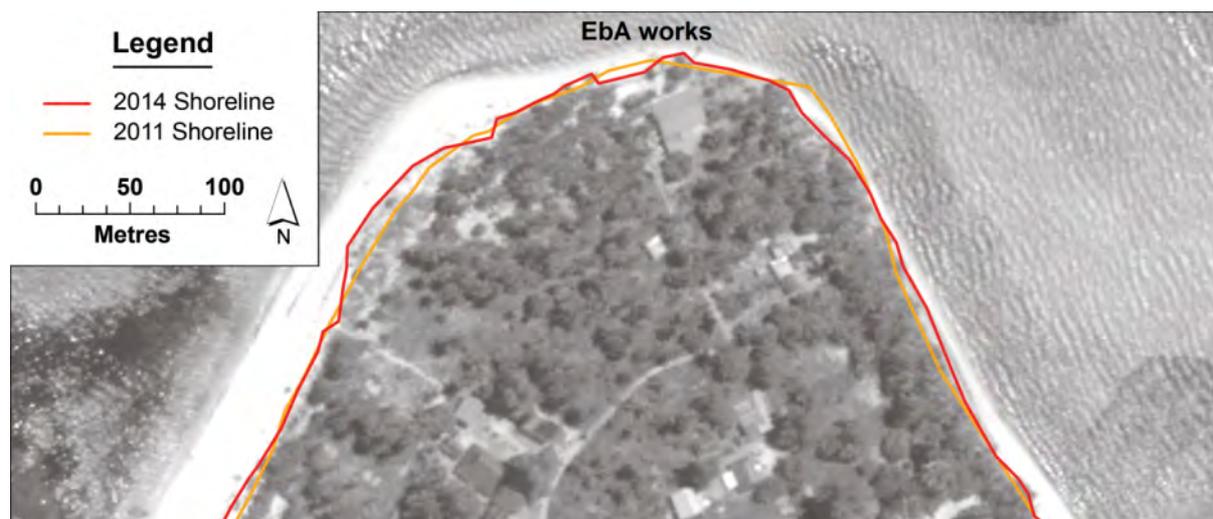
Figure 12. GIS analysis of coastal change at Tabontebike north western coast.

GIS analysis was unable to incorporate 1968 data owing to poor quality of the image. Shoreline change 2011-2014 was variable around the point (Figure 12) with erosion found to the north of the Icehouse building where the profile (Figure 13) was surveyed.

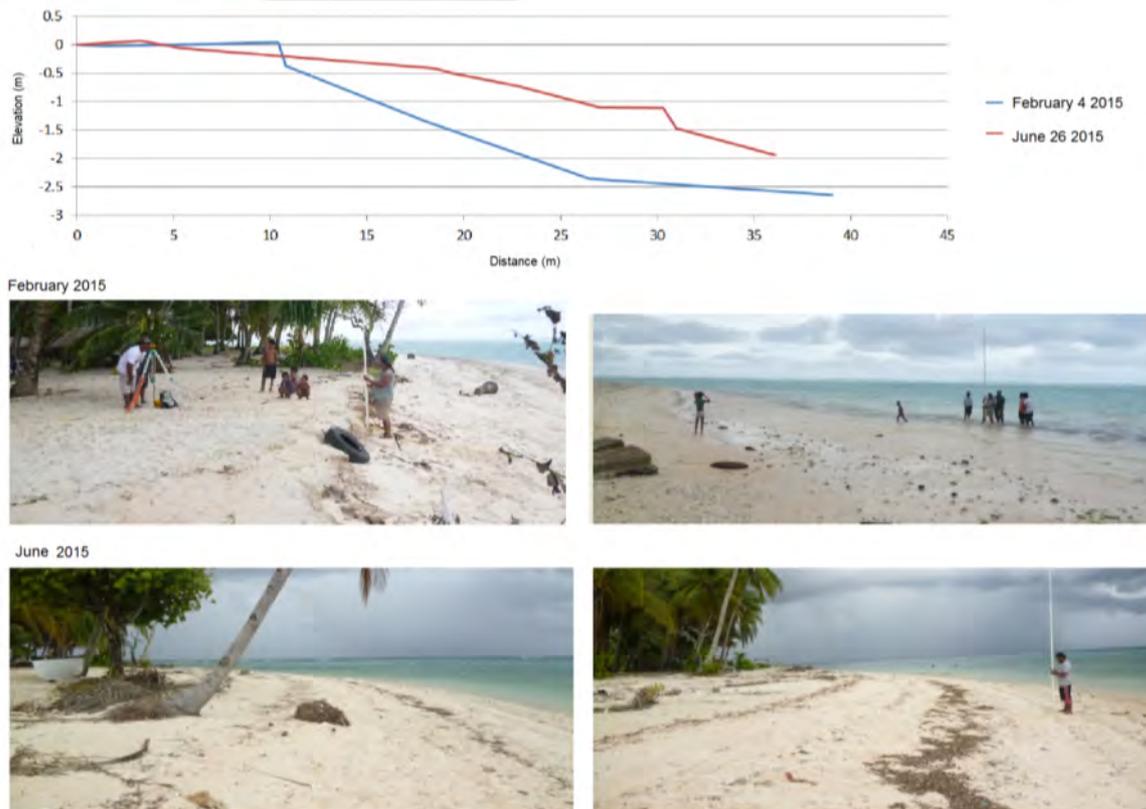
Figure 13. Beach profile transect at Tabontebike.

At the south end of the village, the beach was in a badly degraded condition, with a 1.10 m cliff eroded in the sand beach, which had eroded back to within 10 m of the icehouse (CPPL building). Community members described this as occurring in the last few years, when king tides combine with winds. While EbA is not the best technique for a windward shore, a demonstration was undertaken. A beach monitoring profile was surveyed (Table 9), and benchmarked to the concrete base of the icehouse building.

Volunteers from the community, 16 in number, gathered materials from inland, and also provided coconut string. They built a brush barrier of 8 m in length, and 1.7 m wide, using *te uri* poles and coconut branches. Towards the end of this work a storm occurred at high tide, during which waves were even washing through the ice house from front to back, and further beach erosion was evident. The brush barrier mostly held up even though not completed at the time, and sand was washed through it to deposit and become more solid. In June, the brush structure was still in position, even though storms and people had removed all of the poles. The brush was firm with sand washed through it, and the shoreline has accreted sediment.
