Beach ecosystem based adaptation trials, North Tarawa, Kiribati

Report for the Environment and Conservation Division, Kiribati, as part of the
Australian Aid/ SPREP Coastal Ecosystem Based Adaptation to Climate Change in Kiribati Project

by Dr Joanna C. Ellison, School of Land and Food, University of Tasmania, Locked Bag 1370,
Launceston, Tasmania 7250, Australia

31 January, 2014

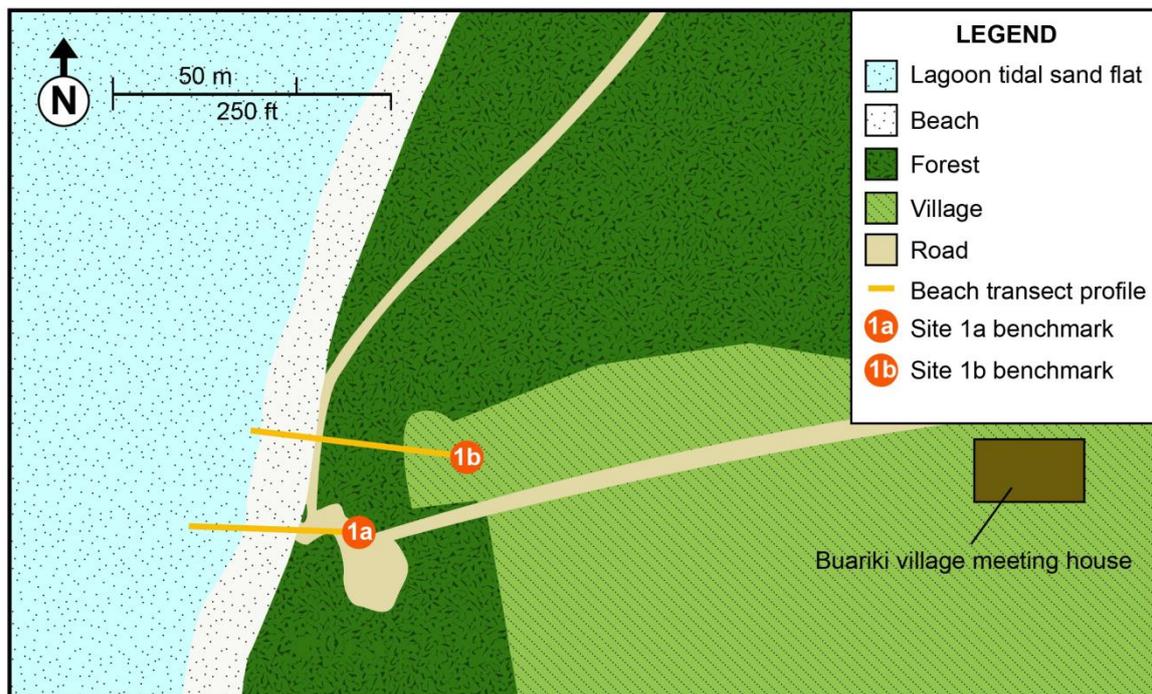
Figure 2. Map of Tabon-te-bike, Buariki, showing rehabilitation sites and beach survey transects.

To the south of this 56 m erosion section at site 1a (Figure 2), there was a similar length of beach with the same orientation, but no evidence of erosion, with denser littoral vegetation inland. This indicated that human access is a contributor to the erosion issues adjacent. The littoral vegetation was dominated by *Premna serratifolia* (Te aroma) (Thaman 1987) and a 5 petal yellow flowered shrub, most likely *Turnera ulmifolia*, a naturalised shrub weed introduced to Tarawa (Space and Imada 2004).

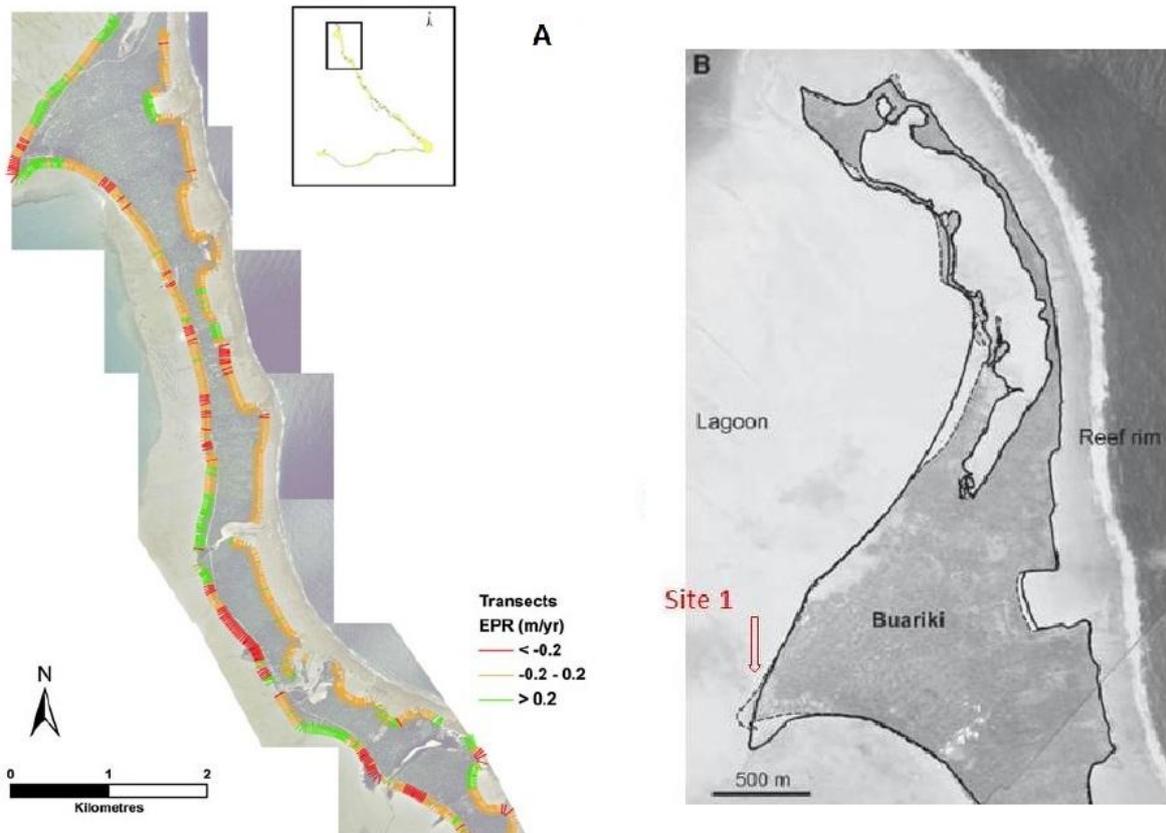
Figure 3. Shoreline changes at Buariki. A) From 1968-1998, adapted from Figure 5 of Biribo and Woodroffe (2013). B) From 1969-2004, adapted from Figure 6b of Webb and Kench (2010), with Site 1 of this report identified in red.

Existing spatial change analysis of the site (Figure 3) was out of date by at least 9 years, so a new analysis was undertaken using historical and most recent imagery. Satellite imagery from 2003 and 2013 was obtained as part of the project, and digital aerial imagery from 1998 was obtained from the Department of Lands, Government of Kiribati. Images were rectified using GPS points taken in the field, and the shoreline edge delineated using the vegetation edge. Results are shown in Figure 4.

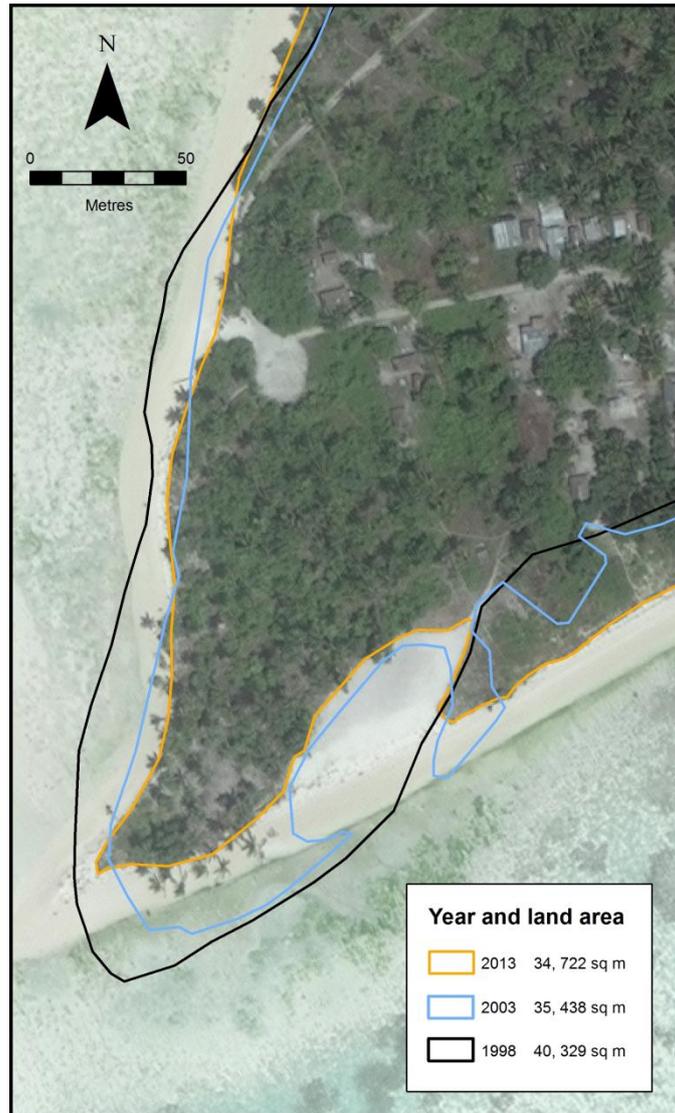
Figure 4. GIS analysis of shoreline change 1998-2013, Tabon-ke-bike, Buariki. The background image is 2013, and the land area calculations are based on the land area shown in the image.

Land area calculations (Figure 4) are of the land area included in the image, and show that the land area of this point of the island has reduced over time. The sand spit recurved towards the south 1998-2003, indicating a change in the prevalent winds such as from south-easterly to north-westerly, but since 2003 the erosion has occurred on both sides of the spit, and with some accretion further towards the southeast. The recent GIS analysis (Figure 4) showed the erosion has resulted in a vegetation retreat rate of 3 m a^{-1} 1998-2003, and 0.7 m a^{-1} 2003-2013. At site 1 (Figure 2), the rates of erosion are greater than the immediately adjacent sections to the north and south, which have both been fairly stable in the last 10 years (Figure 4). This indicates that there may be human impacts in the section where the road meets the coast that are exacerbating erosion.

The beach profile shown in Figure 5 has a flat to concave-up shape in the intertidal part of it towards the right, which is indicative of a beach that is eroding (Bird 2008). The GIS analysis (Figure 4) showed the erosion had resulted in a vegetation retreat rate of 3 m a⁻¹ 1998-2003, and 0.7 m a⁻¹ 2003-2013.

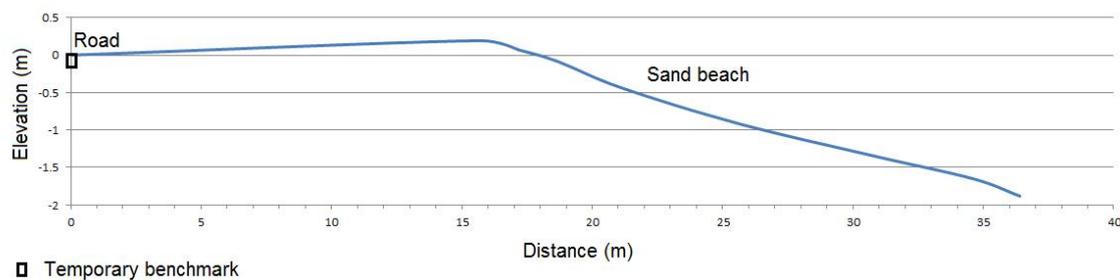
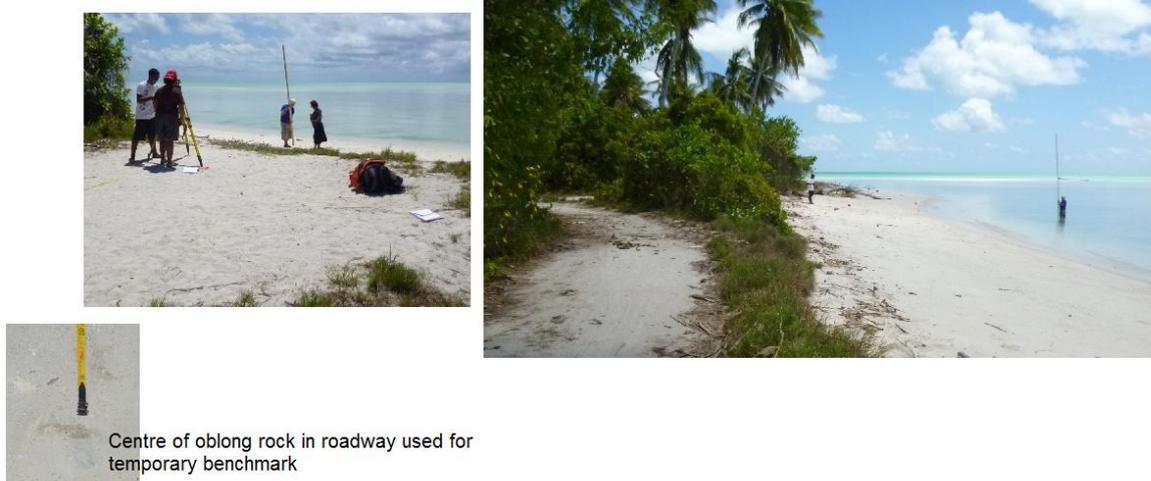
Figure 5. Profile of transect surveyed at Tabon-te-bike site 1a.

A cross sectional profile of the beach was surveyed at Site 1a using a tripod, level and calibrated staff, on 18th September 2013. The location of this site 1a transect is shown in Figure 2. The compass bearing of the transect surveyed was 265° magnetic from the temporary benchmark looking down the transect to offshore. The tripod was set up on the transect line, 14.3 m from the roadway oblong rock used as a temporary benchmark, which is shown in Figure 5. Results are shown in Table 1.

- Watering of beach seedlings by local community.
- Monitoring of seedling growth or mortality, replacement if mortality occurs.
- Transect re-measurement at about 12 month intervals to show erosion or accretion.
- A more secure benchmark needs to be installed or selected, and the road rock (Figure 5) related to this new benchmark by survey.

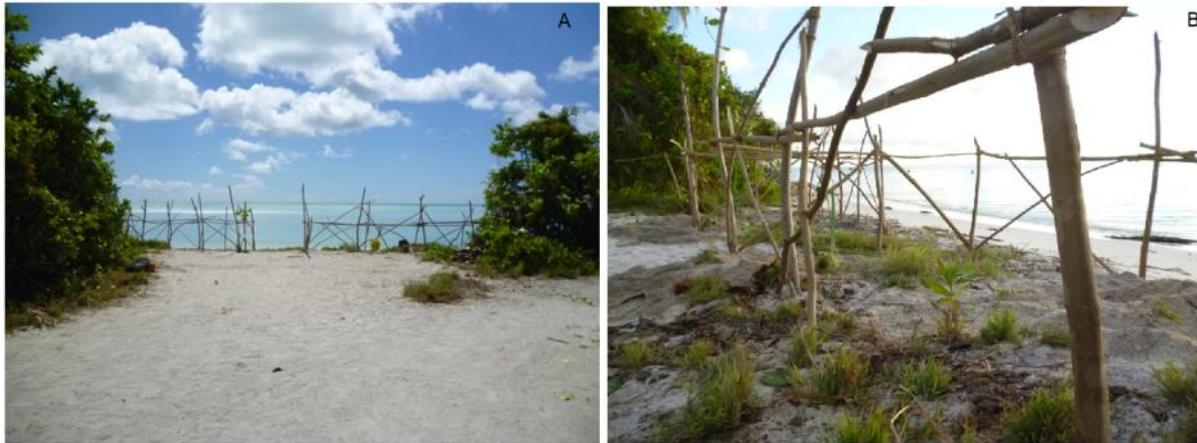
Figure 6. A) Access control constructed by community members at Tabon-ke-bike site 1a. **B)** *Pandanus tectorius* and *Calophyllum inophyllum* wildling seedlings planted inside the enclosures.

Pandanus tectorius (Te kiana) and *Calophyllum inophyllum* (Te itai) (also known as *Alexandrian laurel*) wildling seedlings were collected from underneath parent trees where they would not have had enough light to thrive had they remained. These were planted inside the enclosures, using techniques suited for trees that will grow tall, including deep holes and organic matter layers. The *Calophyllum inophyllum* seedlings measured to the top of stem for future monitoring of growth.

On the main beach access at Tabon-ke-bike, members of the Buariki village community learned of the objective and asked about the dimensions of the area to be fenced, and obtained the necessary materials of poles and rope. The fencing was constructed at the end of the road from the village, across the upper beach slope (Figure 6).

It was decided that because such beach access control (Figure 6) is new in Kiribati, it would be good to introduce a name for it that included in the name the values of why it was done. This would circumvent resistance to change and allow instant understanding among the community regarding the objectives. This was explained to the Buariki community in the meeting house at Buariki, requesting something meaning “beach protection gateway” or the like, and it was decided to have a competition for nominations that evening. Nominations are shown in Table 2.

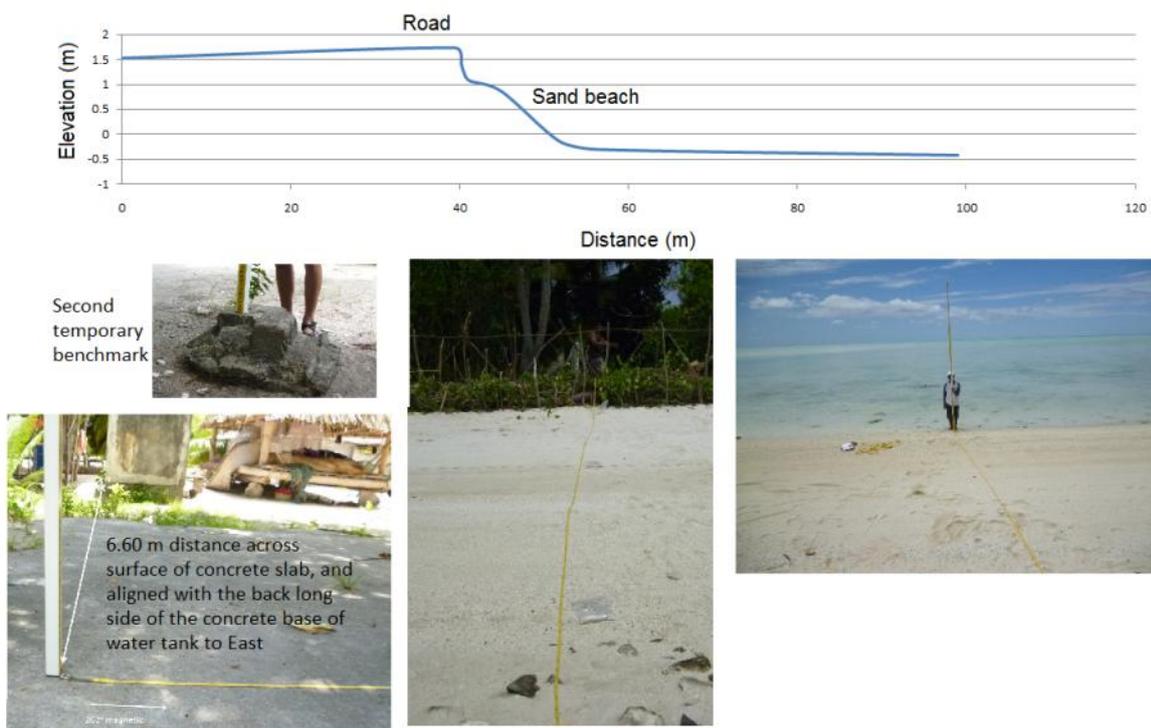
Figure 7. Profile of transect surveyed across the road margin at Tabon-ke-bike (Site 1b).

Figure 7 shows a concave-up shape to the beach profile in the intertidal part of it towards the right, which is indicative of a beach that is eroding (Bird 2008). The GIS analysis (Figure 4) showed the erosion had resulted in a vegetation retreat rate of 3 m a⁻¹ 1998-2003, and 0.7 m a⁻¹ 2003-2013.

A cross sectional profile of the beach was surveyed at Tabon-te-bike Site 1b using a tripod, level and calibrated staff on 12th October 2013. The location of this survey transect is shown in Figure 2. The transect compass bearing was 262° magnetic from the benchmark to offshore, and the temporary benchmark recorded was on a concrete slab, a point on this aligned with back edge of a water tank base to the east (Figure 7). This was located landward of a home, and 6.60 m from water tank's nearest corner. The concrete slab had frayed edges so measurement to the edges was not made. Results are shown in Table 3.

Elevation benchmarks were not available, so MSL position was estimated by comparison of the water level as measured at 1329 that day with the water level recorded that minute on the Betio SEAFRAME tide gauge, using the technique explained in section 5.3 of the Plan- "Beach erosion: Ecosystem based adaptation monitoring plan" that is also an output from this project (Ellison 2014a). Figure 7 shows elevation relative to the Betio tide gauge data datum.

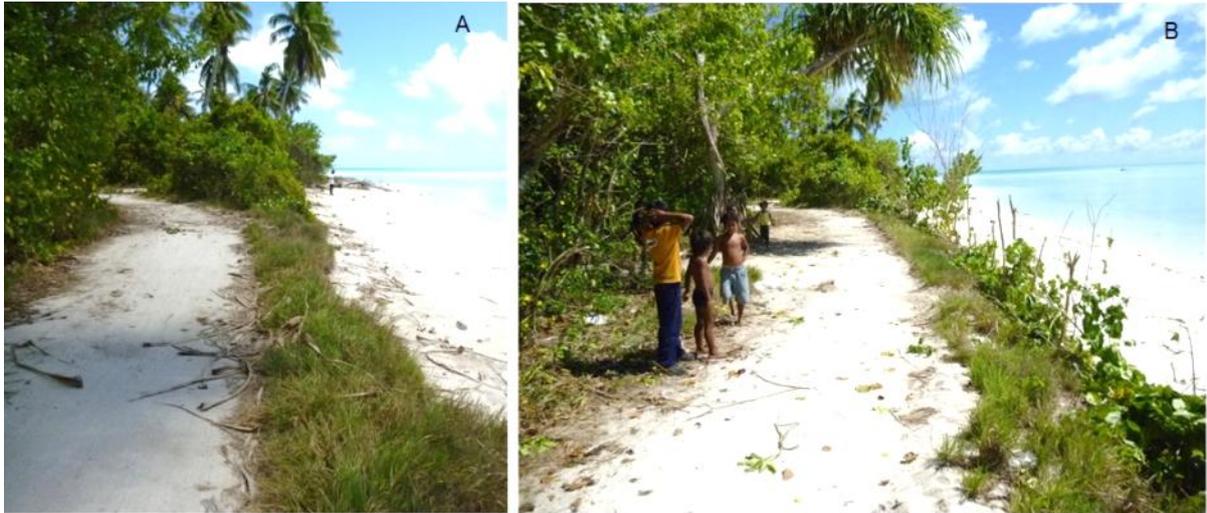
In September 2013, brush cut from the landward side of the road was laid alongside the base of the eroding cliff, and held in place with stakes (Figure 8). This was a temporary trial that one month later proved to be successful, with accretion of sand in the upper beach having occurred in the previous month. This adaptation is a modification of the "Revegetation in coastal areas Guidelines G-7.3" of Page and Thorp (2010), who described use of seed laden brush laid on the sand, to trap sand, and also prevent human access to fragile or rehabilitated areas. At site 1b, brush placed below the eroding cliff is intended to also reduce wave action as well as trap sand.

Figure 8. Site 1b at Tabon-ke-bike looking south in September 2013. **A)** Before, vegetation on the left of the picture is pushing traffic onto the narrow grass edge of the beach. **B)** After, vegetation was cut back along where the children are standing, and a temporary barrier placed along the grass edge of the beach to prevent human access.

At Site 1b, ecosystem rehabilitation options have been recognised to be the best option (Juillerat 2013), including revegetation and access control. It must be recognised however that this site has previously experienced some 200 m of erosion, and there is now less than 1 m left as a buffer between the road and the beach, it would have been better to have at least 5 m for these trials. The section adjacent to the road was too narrow to risk tree planting, as a hole may cause the seaward side to drop off and so leave not much left. Truck tracks indicated that vehicles were also driving close to and even over the grass of the vulnerable edge. It was decided to prune the bushes on the landward side of the road that the trucks were swerving seaward to avoid (Figure 8).

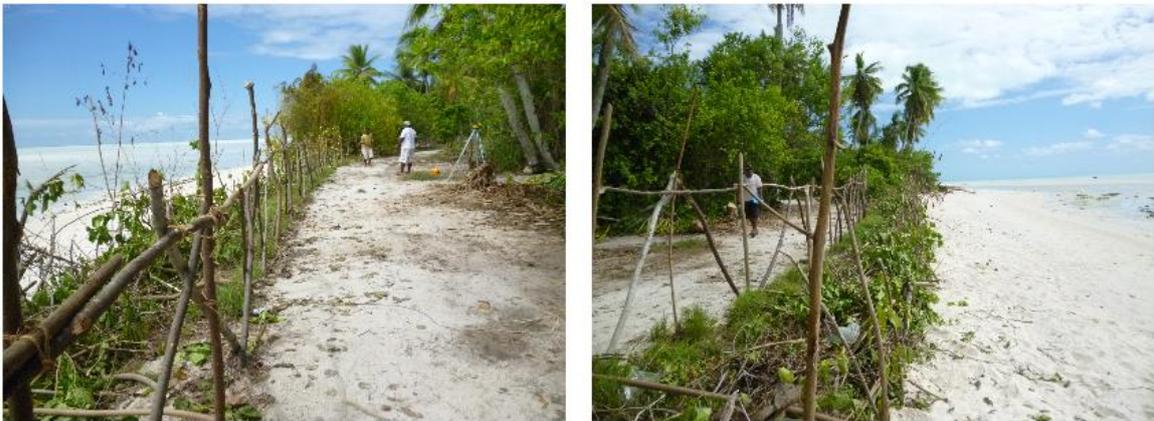
In October 2013, the temporary brush barrier was rebuilt to be a more secure structure, also the road edge fenced to prevent human or traffic access over the fragile grass edge (Figure 9). Traditional coconut string was used to lash poles, thought to have a usage timeframe of about 2 years. The green leaves that can be seen in the barrier at the beach cliff edge (Figure 9) is just because the brush is fresh cut, it later browned off (Figure 10). Care was taken not to cover or disturb the live grass.

Figure 9. Site 1b at Tabon-ke-bike in October 2013, after the brush wave barrier was made more substantial, and the road edge was fenced to control disturbance.

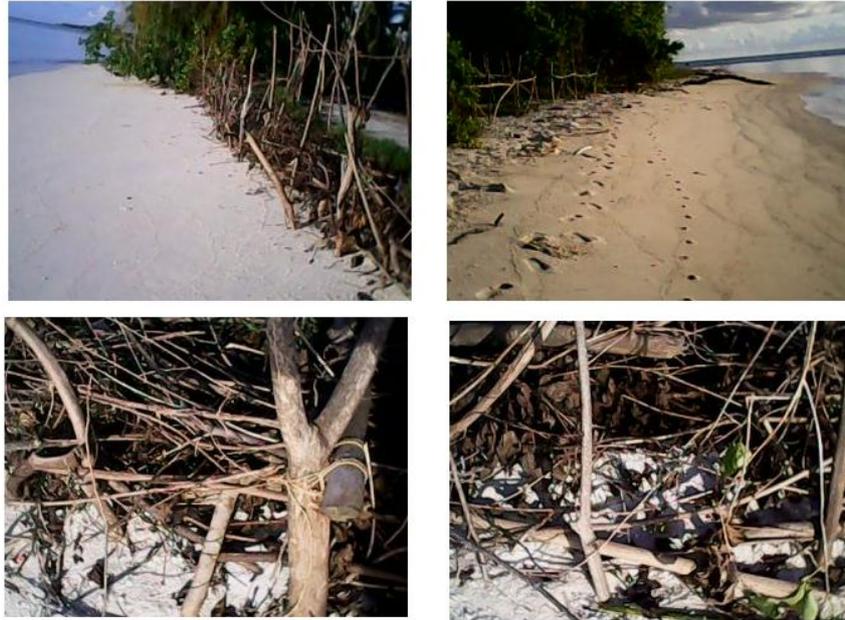
Figure 10. Site 1 about a month after the EbA trials were commenced, these photos were taken by Arawaia Moiwa.

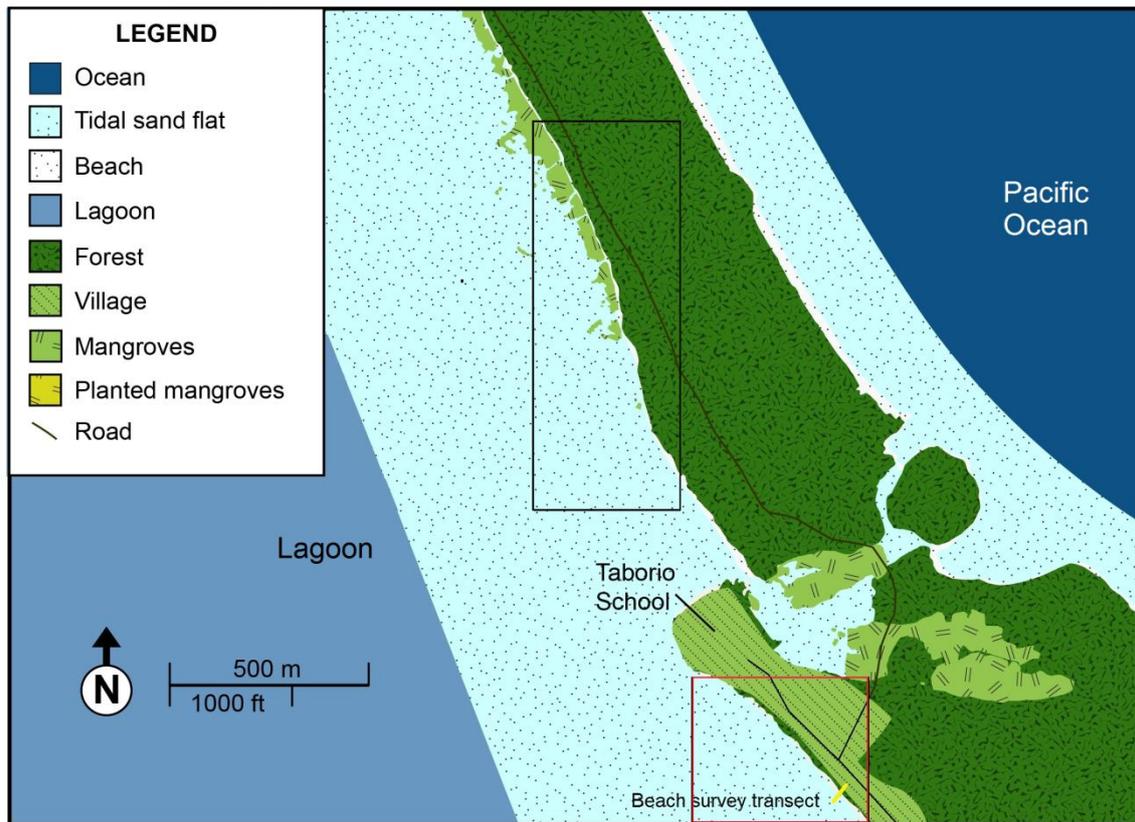
Figure 12. Map of vegetation and landuse of Nooto, showing GIS and beach survey locations.

A reconnaissance of beach condition of the southern lagoon beach (Figures 12 and 13) commenced at the meeting house at 01° 30.898' N; 173° 00.438' E located to the south of the road junction, and extended towards the north to the rock point north of the Taborio Catholic secondary school at 01 31.243° N; 173 00.120° E (Figure 12).

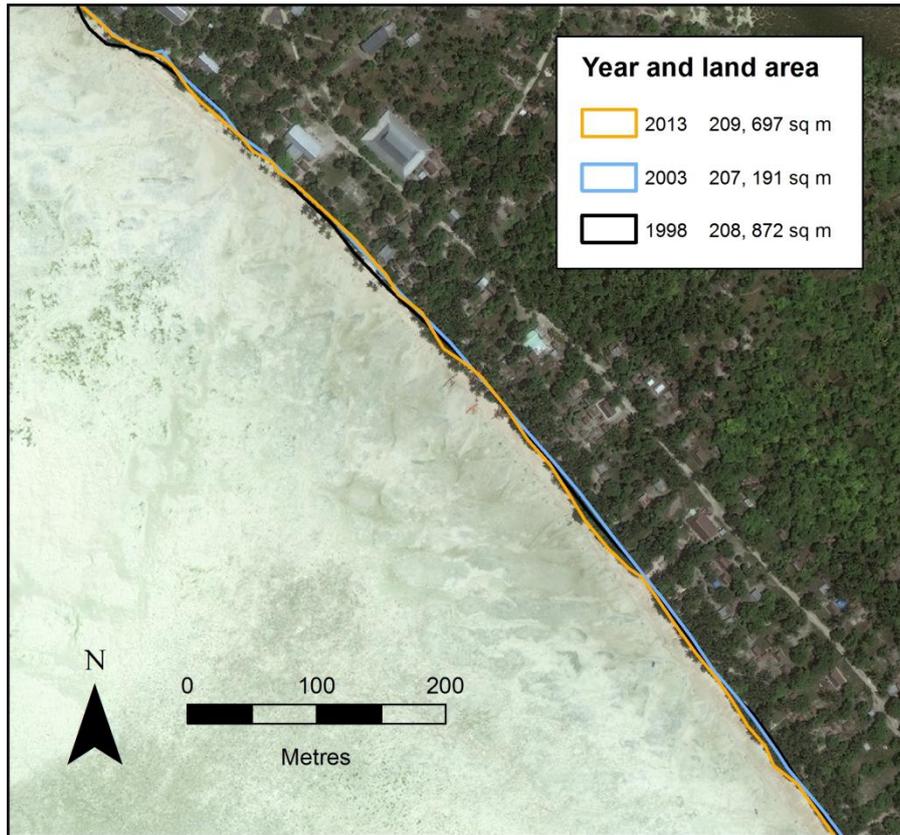
Figure 13. GIS analysis of shoreline change 1998-2013 at Nooto Ramsar site southern lagoon shore beach, of the southern red box area shown in Figure 12. The background image is 2013, and the land area calculations are based on the land area shown in the image.

Spatial change analysis results and land area calculations (Figure 13) show that this section of the coast has been largely stable in the last 10 years, whereas results from 1968-1998 showed it to be accreting (Biribo and Woodroffe 2013). The beach shoreline of the northern lagoon shore of the northern box area shown in Figure 12 was also analysed by GIS for comparison with the southern village section, and results are shown in Figure 14. This analysis focussed on the beach of the northern section, and change in the mangrove cover is discussed in a separate report from this project (Ellison 2014b)

The spatial change analysis found that while the south Nooto lagoon beach was advancing seawards with accretion 1968-1998 (Biribo and Woodroffe 2013), after 1998 the beach position showed no further beach progradation (Figure 13). Reconnaissance carried out in October 2013 found that the beach has evidence of decline in beach values (Figure 15) and indications of erosion with a concave-up beach profile (Figure 16). This reconnaissance can identify some priorities for management of the southern lagoon beach at Nooto:

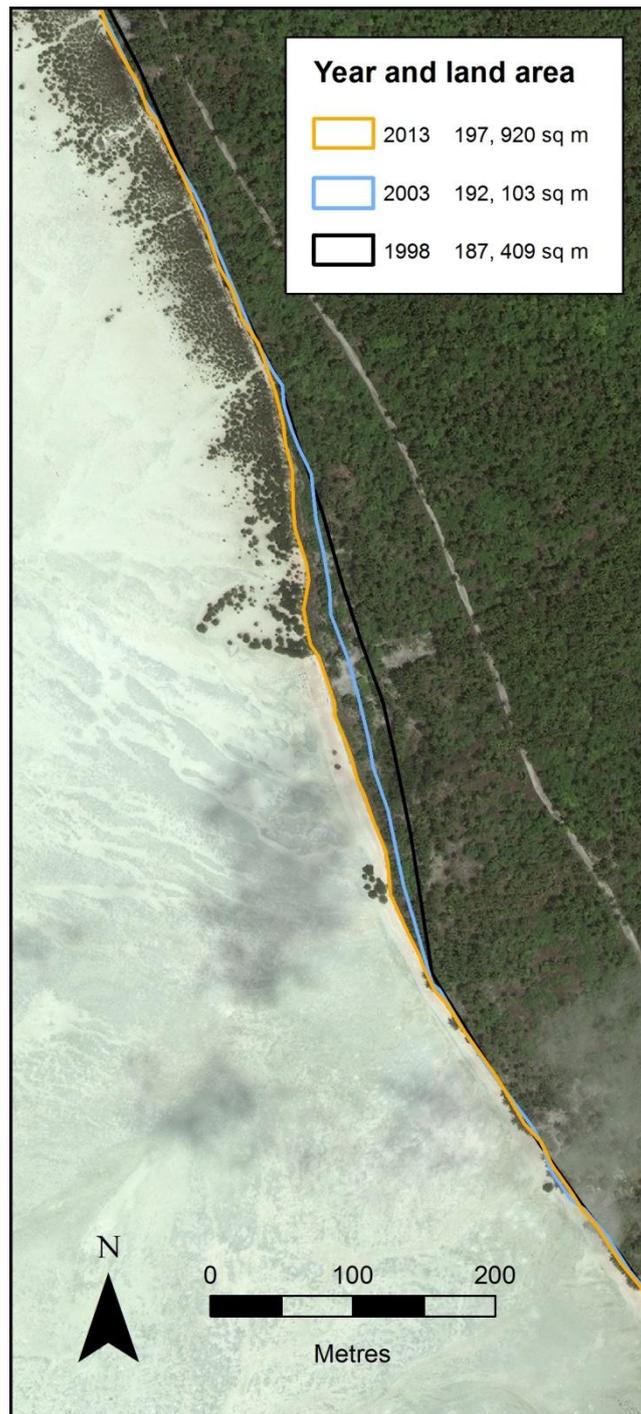
Figure 14. GIS analysis of beach shoreline change 1998-2013 at Nooto Ramsar site northern lagoon shore beach, of the northern black box area shown in Figure 12. The background image is 2013, and the land area calculations are based on the land area shown in the image.

Results of spatial change analysis 1998-2013 (Figure 14) showed that the beach shoreline to the north of the inner lagoon entrance (Figure 12) has prograded over the last 15 years in the central section of the area analysed, and has been largely stable to the north and south of the area analysed. The progradation in the centre of Figure 14 has been fairly rapid, at a rate of about 3 m a^{-1} .

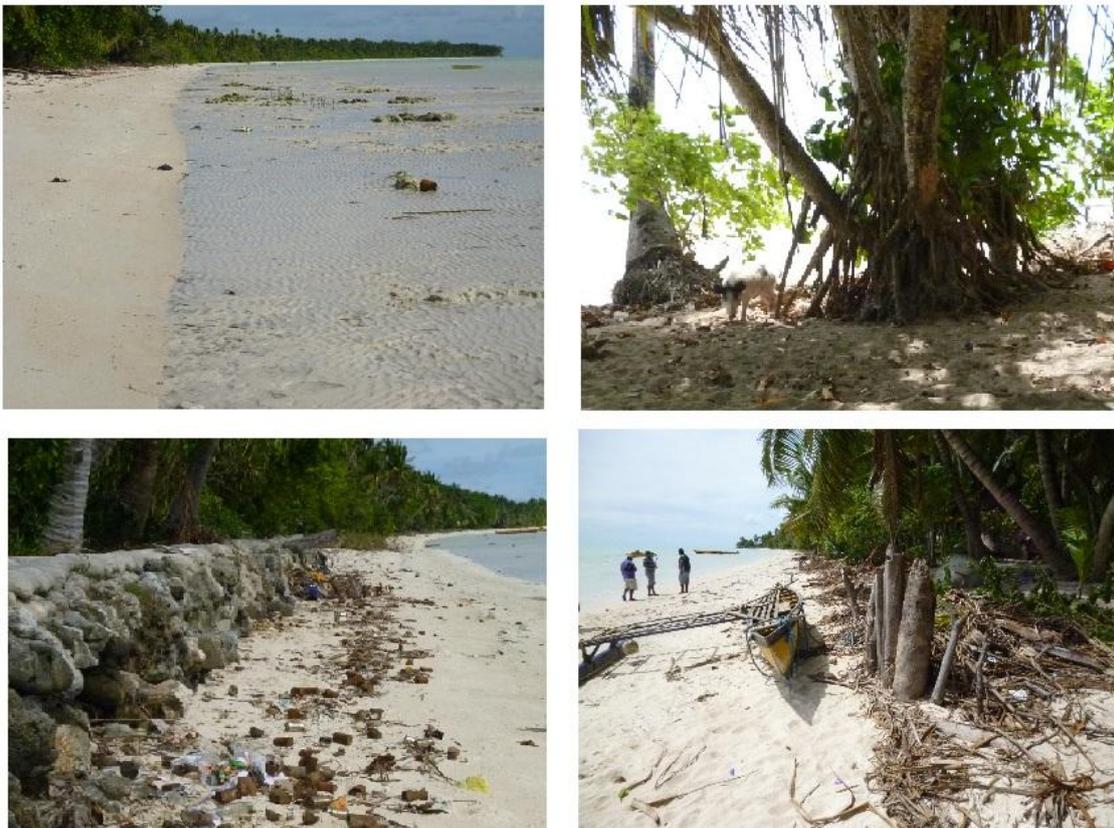
The entire section of beach showed human impact (Figure 15), including:

- human trampling of beach edge vegetation
- low biodiversity of beach edge vegetation
- access pathways causing vegetation-free gaps along the beach vegetation edge
- poor vegetation density and diversity along the upper beach
- concave and narrow sections of beach
- pigs tied to beach edge trees digging up sand and causing disaggregation and erosion
- sand mining hollows on the upper beach at about the level of the absent vegetation line
- some informal seawalls disrupting beach natural conditions
- a large coral/ beachrock constructed seawall alongside the Catholic secondary school
- cans and other rubbish all along the beach particularly offshore of the school's seawall
- human faeces on both the open beach and on rocks offshore of the secondary school.

Figure 15. Central open beach section of the lagoon shore of the Nooto Ramsar site.

The beach shape showed poor accretion with flat to concave-up profiles in some sections. The beach was narrow, and the high tide mark was close to the top of the beach slope.

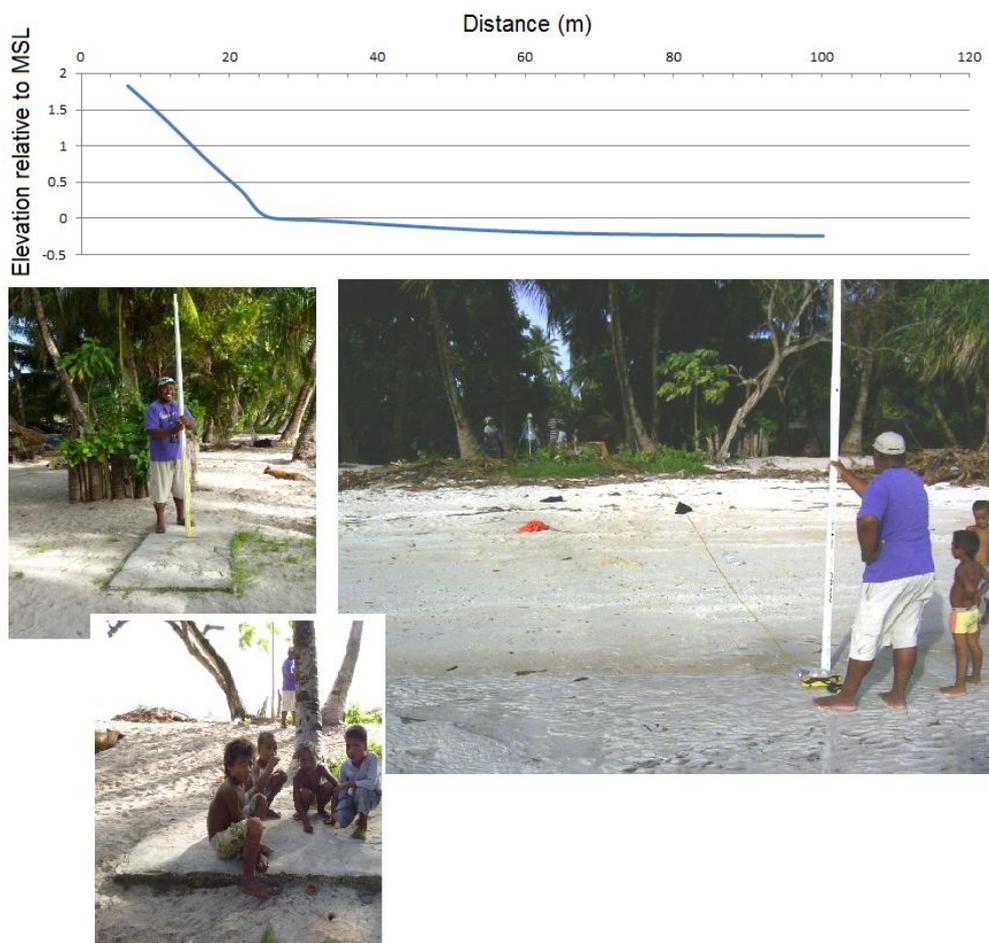
In order to evaluate the beach shape, and to provide a baseline for future monitoring, a profile was surveyed on the beach behind the village meeting house, at $01^{\circ} 30.898' N$; $173^{\circ} 00.438' E$. This section was heavily trampled by people, and loose pigs were also around, such that ground vegetation was minimal.

A concrete block at village level behind the beach slope was selected as an elevation benchmark, to allow the profile to be re-surveyed in future. The point chosen was the exact centre of its diagonals (Figure 16). Survey results are shown in Table 4. The transect commenced between the two *Cocos* trees in from of this, with a magnetic bearing of 225° from the slab to offshore.

Figure 16. Surveyed beach profile on the lagoon shore at the Nooto meeting house.

Elevation benchmarks were not available, so MSL position was estimated by comparison of the water level as measured at 1702 that day with the water level recorded that minute on the Betio SEAFRAME tide gauge. This technique is explained in section 5.3 of Ellison (2014a), and section 5.2 of that Plan uses results from Nooto (Table 4) to demonstrate how to do beach profile data analysis. Figure 16 shows elevation determined in this manner relative to the Betio tide gauge data datum.

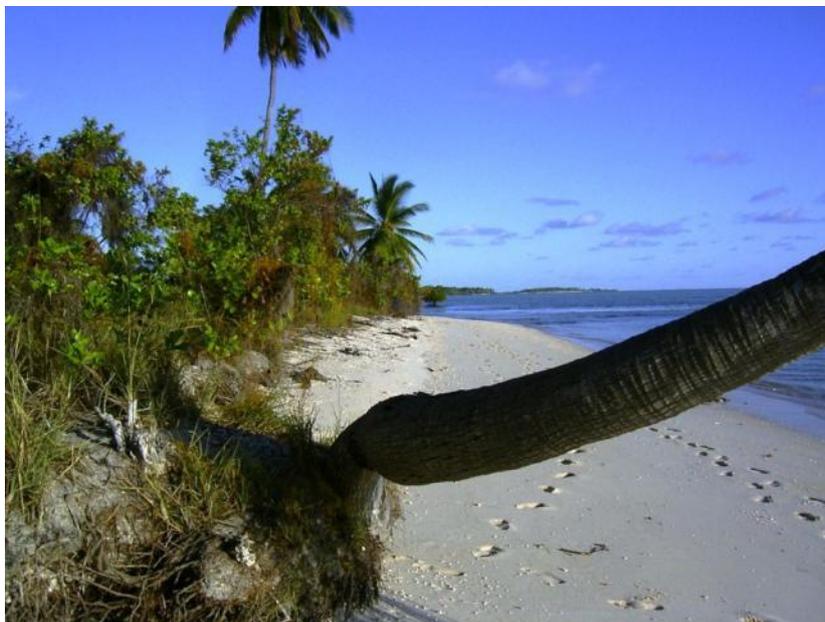
Figure 17. Eroding beach describe with the lagoon passage of Abaokoro Bridge in the background.

Below the scarp is loose calcareous beach sand with intact bivalves and whorl shells, and along most of the stretch the high tide wave mark is reaching just below the scarp. There is evidence of higher water washout from the scarp, leaving roots exposed with the finer organic sand of the platform material eroded out. This shoreline erosion has resulted in resilient trees of *Cocos* and *Calophyllum inophyllum* being undercut and near islanded. The intertidal beach profile however is convex-up, and there is a large accumulation of sand at the mouth of the passage over which the bridge is constructed. Longshore drift at this site appears to be East to West, and it is possible that the strong currents through the bridge causeway may be causing eddy deposition to the west, that is partly blocked from free movement by a beach rock outcrop the west of the sand buildup and the causeway.

- Community consultation
- Spatial change analysis of trends of erosion, to identify rates of erosion and causes
- Beach profile survey and later re- measurement to monitor erosion or accretion
- Beach vegetation replanting and reduction of human disturbance factors.
