Kiribati chemical and waste management advice and Banaba reconnaissance mission

Written by:
Melanie Ashton and Mike McRae Williams

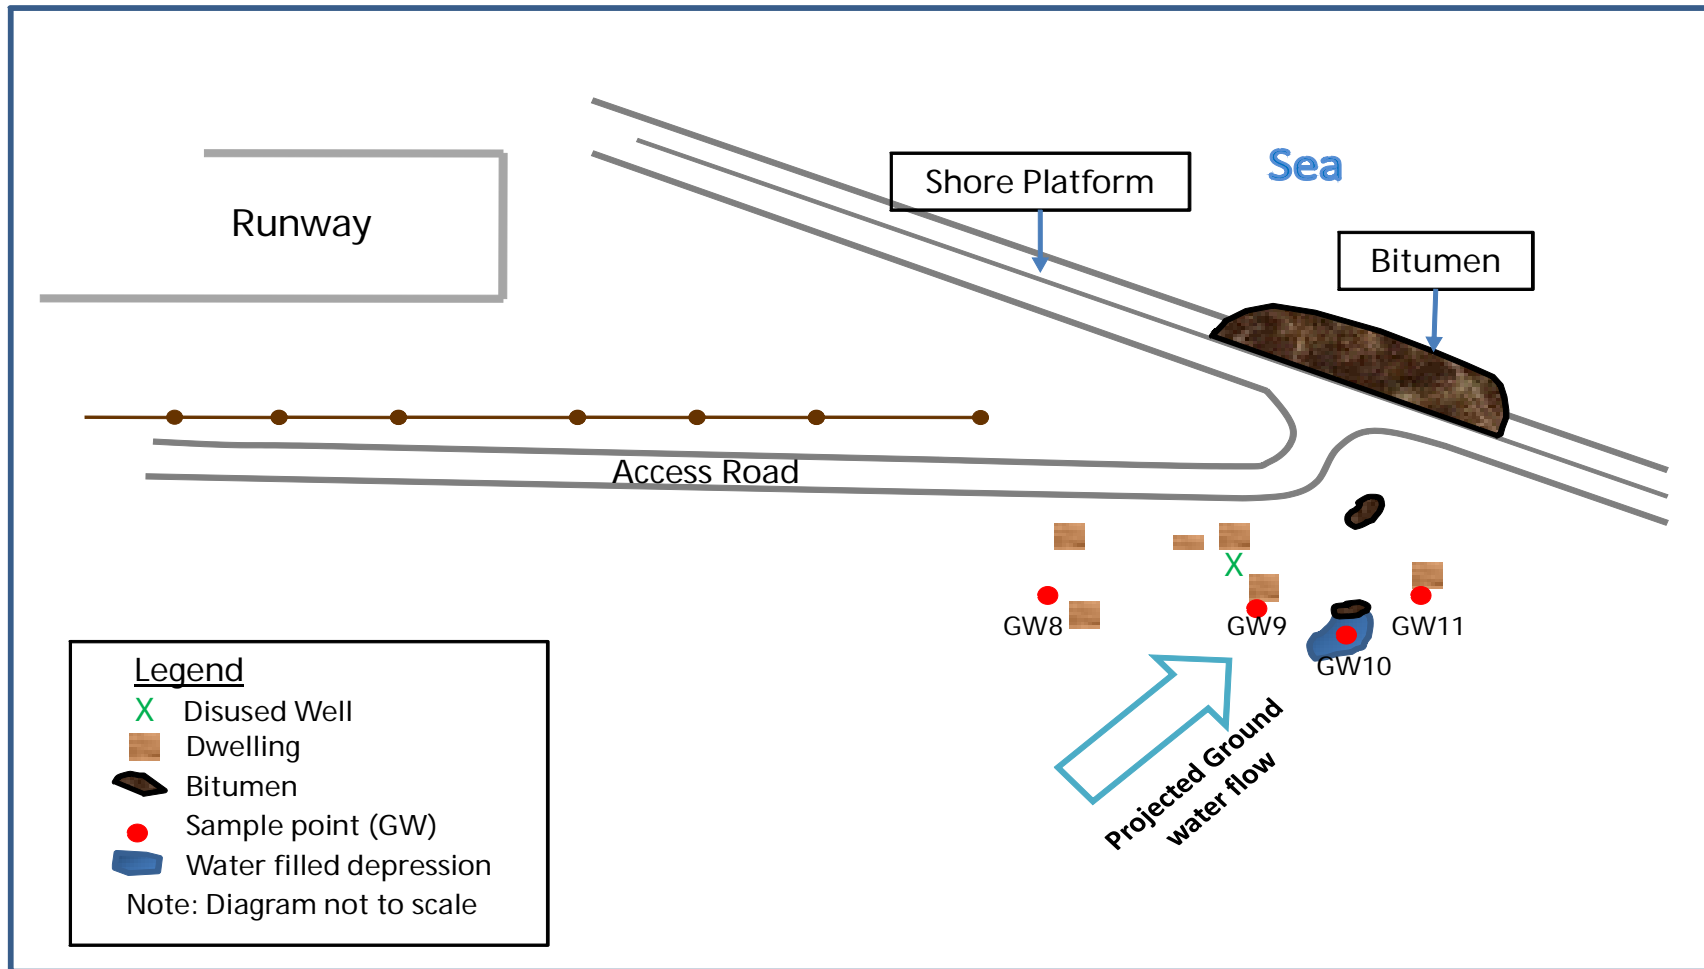
Figure 1: Tarawa Airstrip Bitumen and Community Infrastructure Location

The bitumen occurs in two areas; to the north of the runway and to the south of the runway (Plate 1). In 2006, the bitumen south of the runway was observed flowing into an old well (Figure 1) and concern was raised that this may be contaminating the groundwater. Since the groundwater is accessed by local households through wells for drinking water, the worry is that a potential health issue existed. Consequently, MELAD commissioned a further site assessment including sampling those residents wells in close proximity to the bitumen contaminated area.

On visiting the site it was discovered that much of the bitumen south of the runway had been removed to make way for a new house (Plate 2) and been deposited on the shore platform in the intertidal zone and in a depression containing ground water located adjacent to the dwellings (Figure 1).

The original contamination by the bitumen was via an old well that was located approximately 40 metres north east of the original dwellings and 15 metres north of the existing depression (Figure 1). This well

Contamination entering the water table in this location considering the most likely movement direction of the groundwater (east and north east) would have migrated away from the existing leaf houses and the wells now being used (Figure 1).

The recent construction of a new cement block house and the pushing of the bitumen into the sea and the groundwater depression may have the effect of increasing the potential for contamination of the groundwater in a location, which could affect at least one of the village house wells as the depression is directly east of this house (Figure 1).
